UNIVERSITA' DI ROMA "TOR VERGATA"

TEST ON PRECAST TUNNEL SEGMENT WITH FIBERGLASS REINFORCEMENT

CUSTOMER: ATP S.p.A.

January 2014

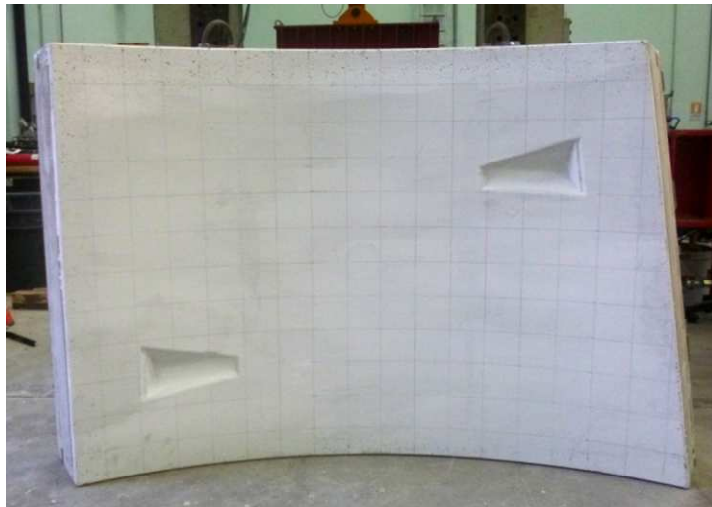
The test is carried out on a precast tunnel segment characterised by a thickness of 250 mm, a length of about 1585 mm and a width of about 1200 mm (Fig. 1).

The segment was cast with concrete characterized by a cubic strength equal to 61.7 MPa.

Figure 1. Segment geometry

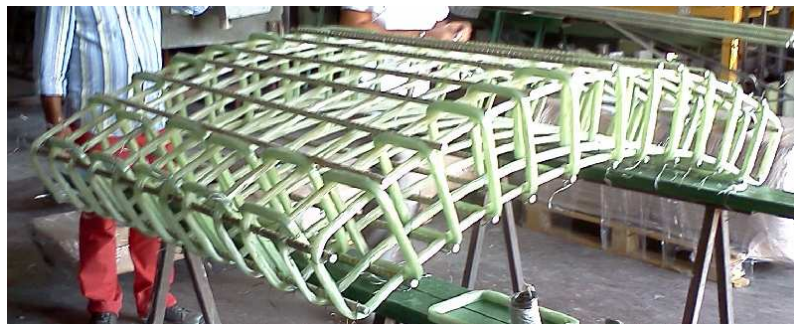
The segment is reinforced with a fiber glass cage (FGR – fiber glass reinforcement), made of 13+13 \varnothing 14 longitudinal bars, 13+13 \varnothing 12 straight crossbars and 42 \varnothing 14 brackets hoops on the perimeter (Fig. 2) with minimum cover of 15 mm.

Figure 2. Fiber Glass cage

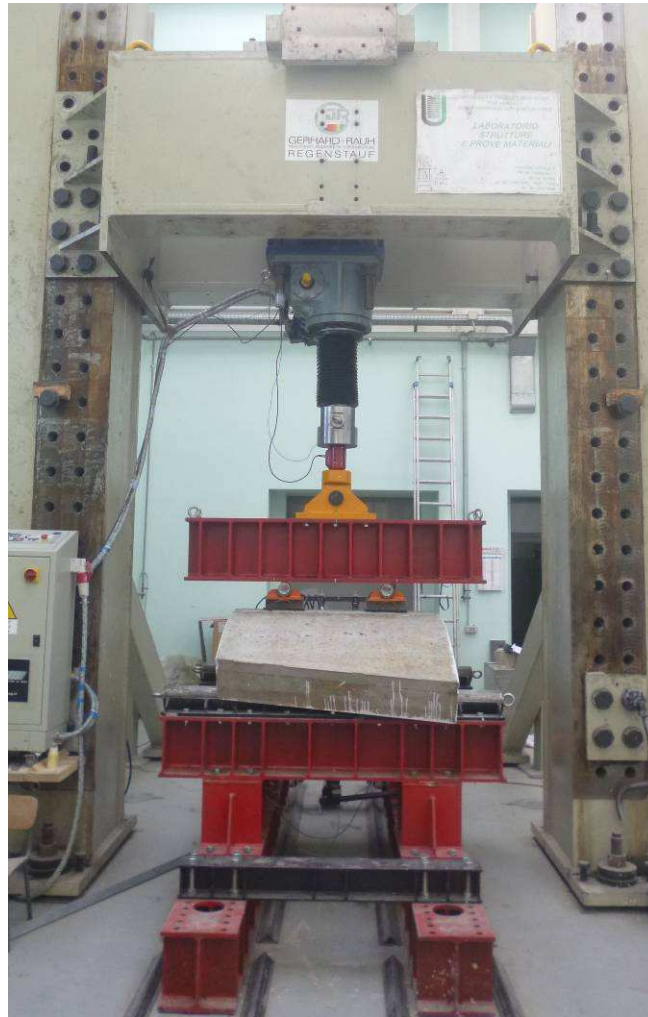
The test was performed with the loading set-up illustrated in Figure 3 and Figure 4, in displacement control, under a contrast frame of 4000 kN by adopting a 1000kN electromechanical jacket, with a PID control and by imposing a stroke speed of 10 – 16 $\mu\text{m}/\text{sec}$.

The segment was placed on cylindrical supports and the load, applied at midspan, was transversally distributed by adopting a steel beam as shown in Figures 3 and 4.

Figure 4. Bending test set-up

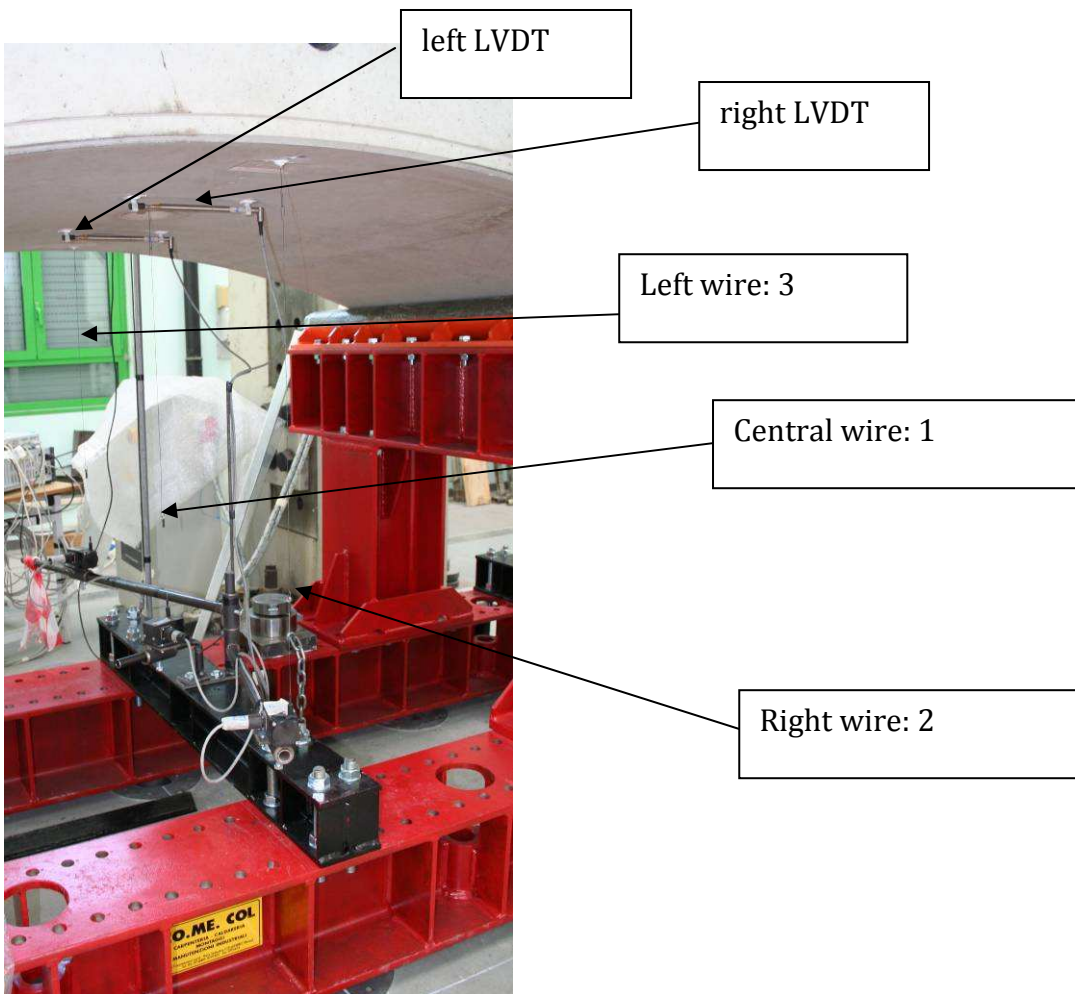
- the load F , measured by means of a 1000kN load cell with a precision of 0.2%;
- the midspan displacement measured by means of three potentiometer wire transducers placed along the transverse line (Fig. 5);
- the crack opening at midspan, measured by means of two LVDTs (Fig. 5).

Figure 5. Bending test instrumentation

In Figure 7 it is plotted the load – displacement relationship related to the three wire transducers (Fig. 5).

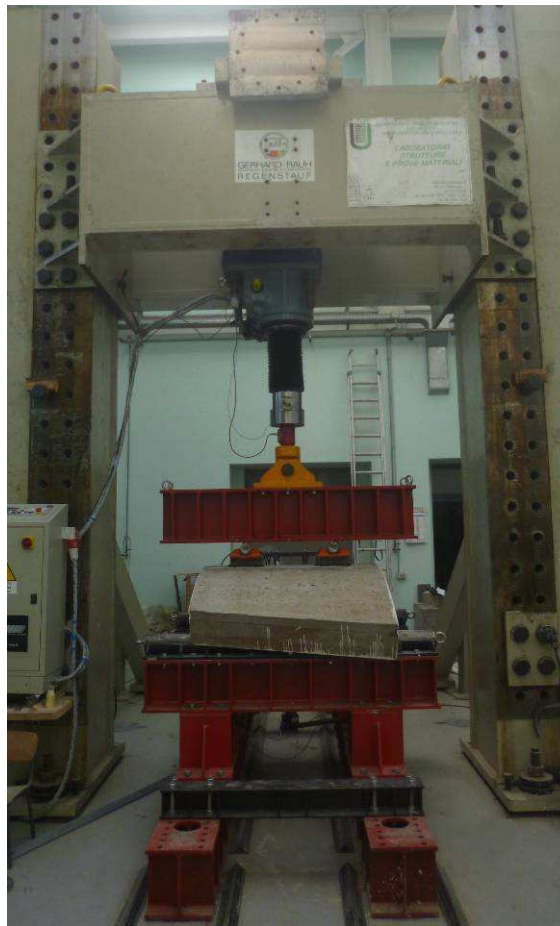
The bending test set up is highlighted in Figure 6.

Figure 6. Segment 150: Test set-up

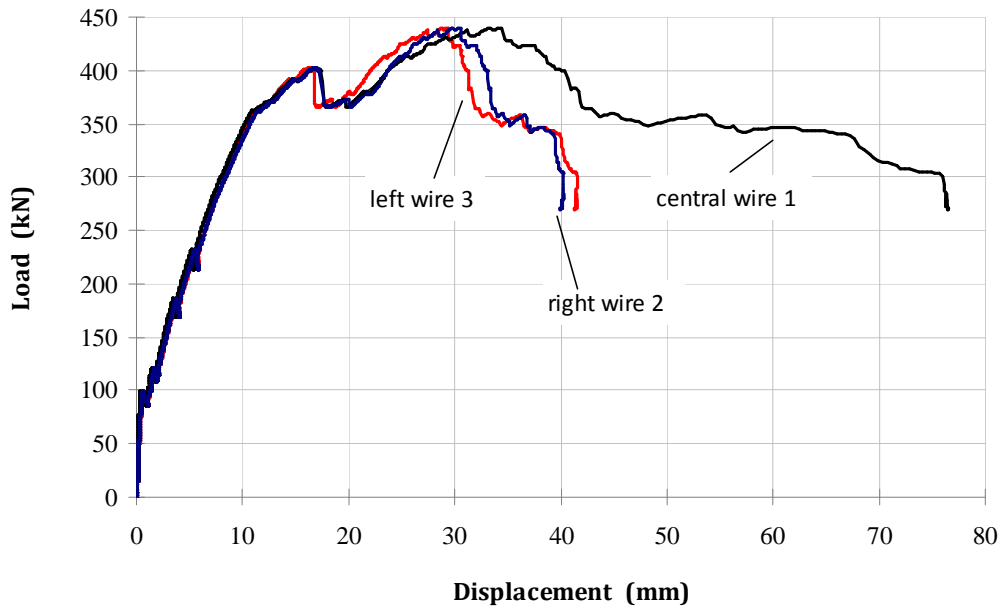
It is worth remarking that the three instruments, located in the midspan, measured almost coincident displacement values up to a displacement of 30mm, highlighting a homogeneous behaviour of the segment in this direction.

The **maximum load** is equal to about **430 kN**.

Figure 7. Load displacement curves.

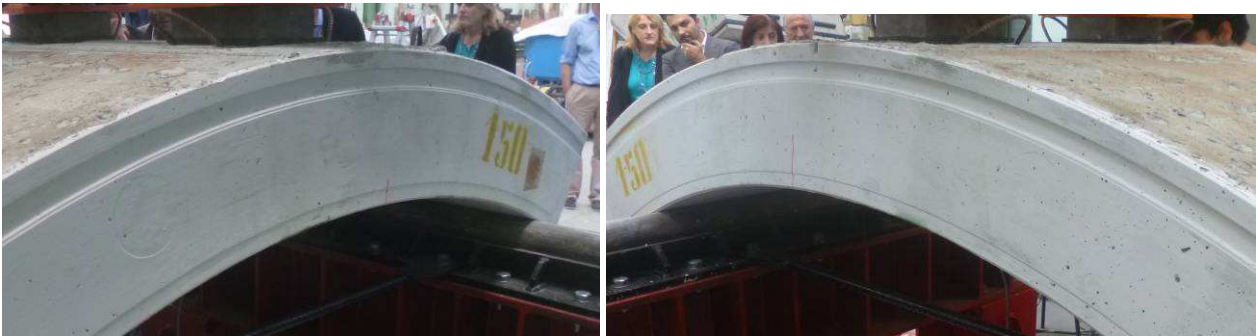
The first crack appeared for a load level of about 97.5 kN (Fig. 8 and Fig. 9)

Figure 8. First crack, lateral surfaces

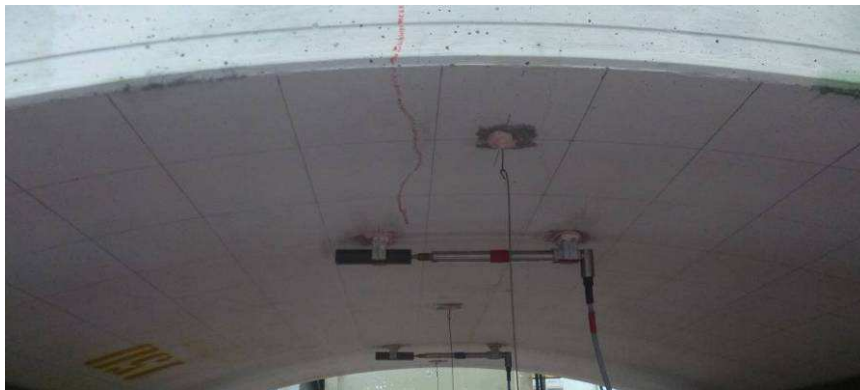
Figure 9. First crack, intrados surface

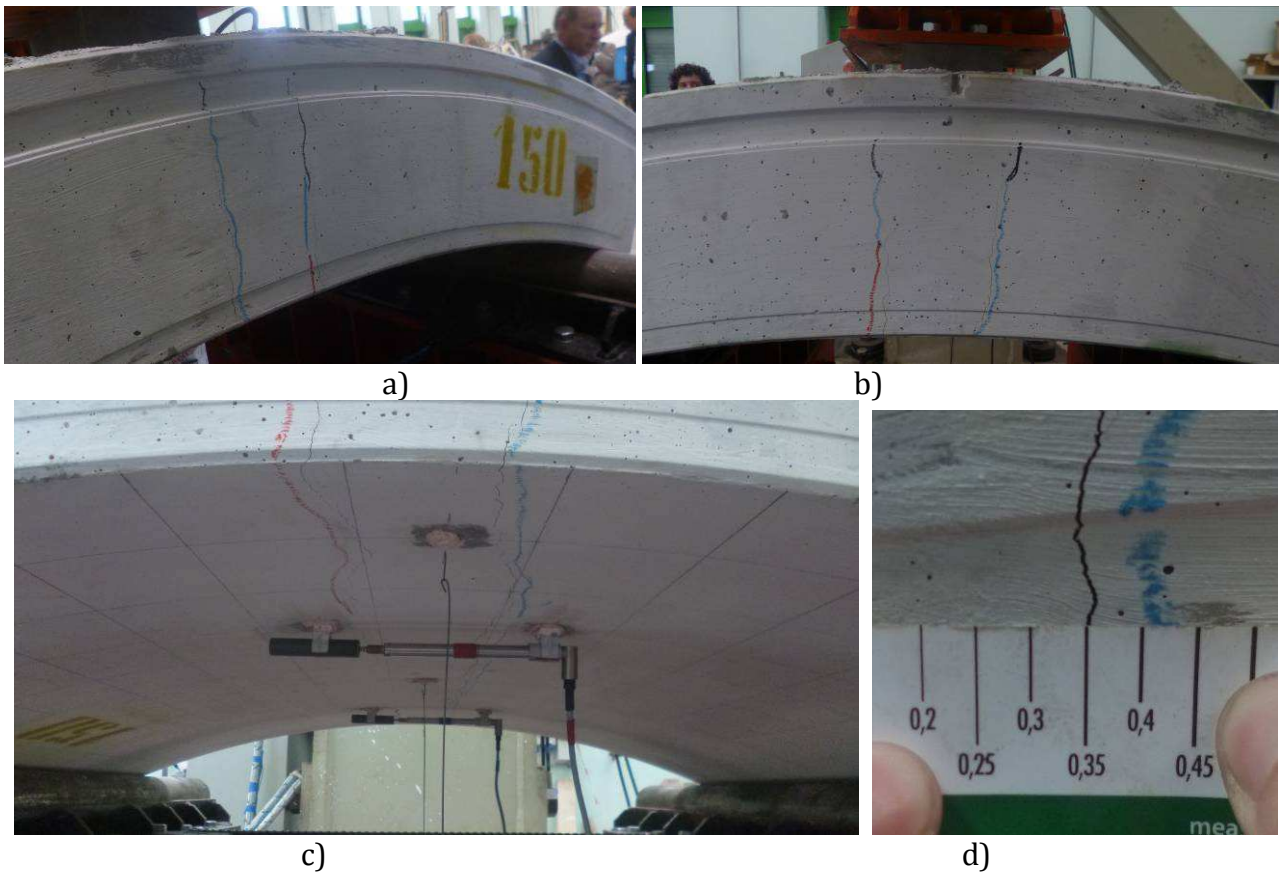
The crack pattern for a load level of **120 kN** is shown in the following Figure 10.

Figure 10. Load level 120 kN. Crack pattern; a) left lateral face, b) right lateral face; c) intrados, d) maximum crack width

The maximum crack width is equal to about 0.35 mm, as highlighted in Figure 10d.

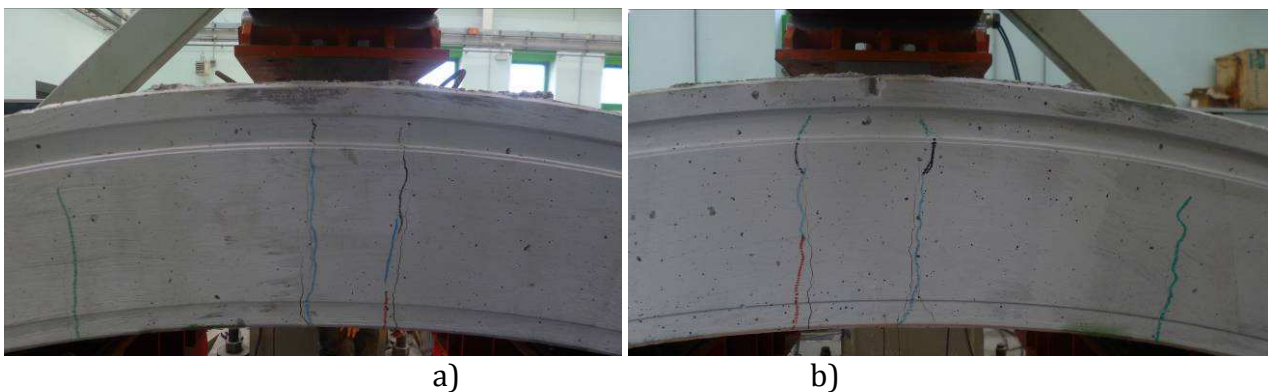
The crack pattern for a load level of **185 kN** is shown in the following Figures 11 and 12. The maximum crack width is equal to about 0.8 mm, as highlighted in Figure 12b.

Figure 11. Load level 185 kN. Crack pattern; a) left lateral surface, b) right lateral surface.

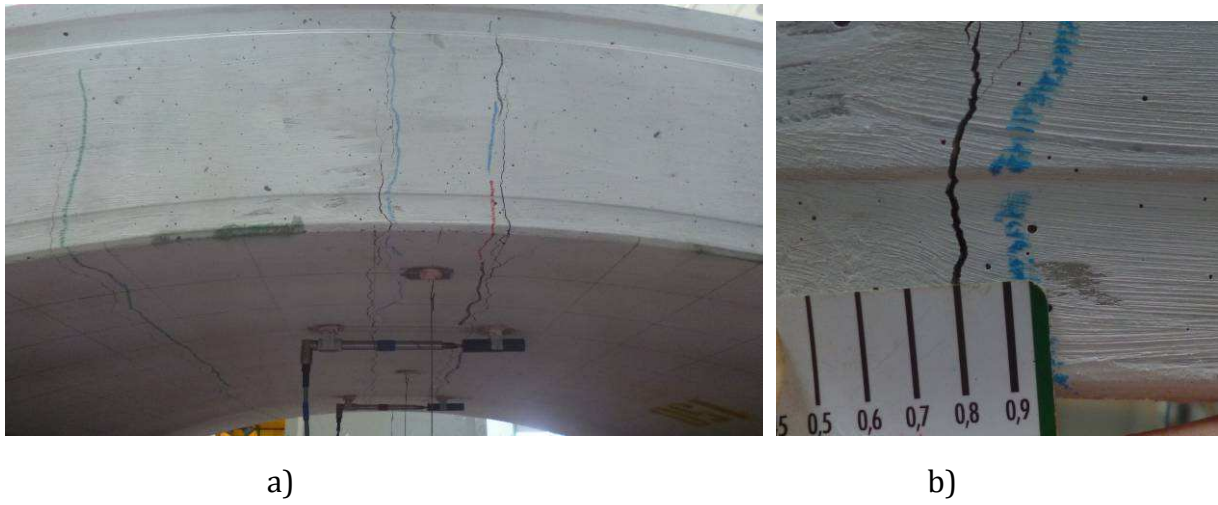
Figure 12. Load level 185 kN. Crack pattern; a) intrados, b) maximum crack width

The measured values refer to the two main cracks that get across the instruments (Fig. 12).

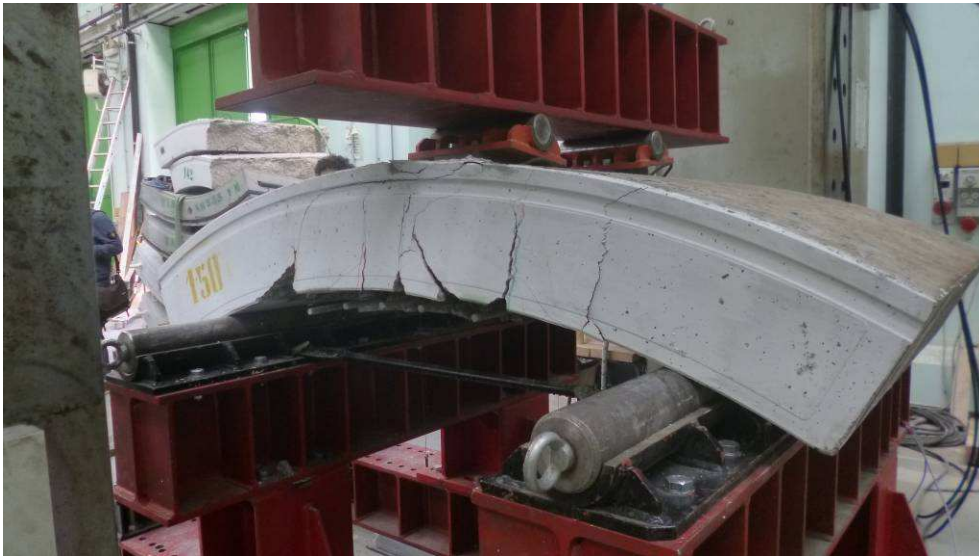
The failure condition is shown in Figures 13 and 14.

Figure 13. Failure condition right lateral surface

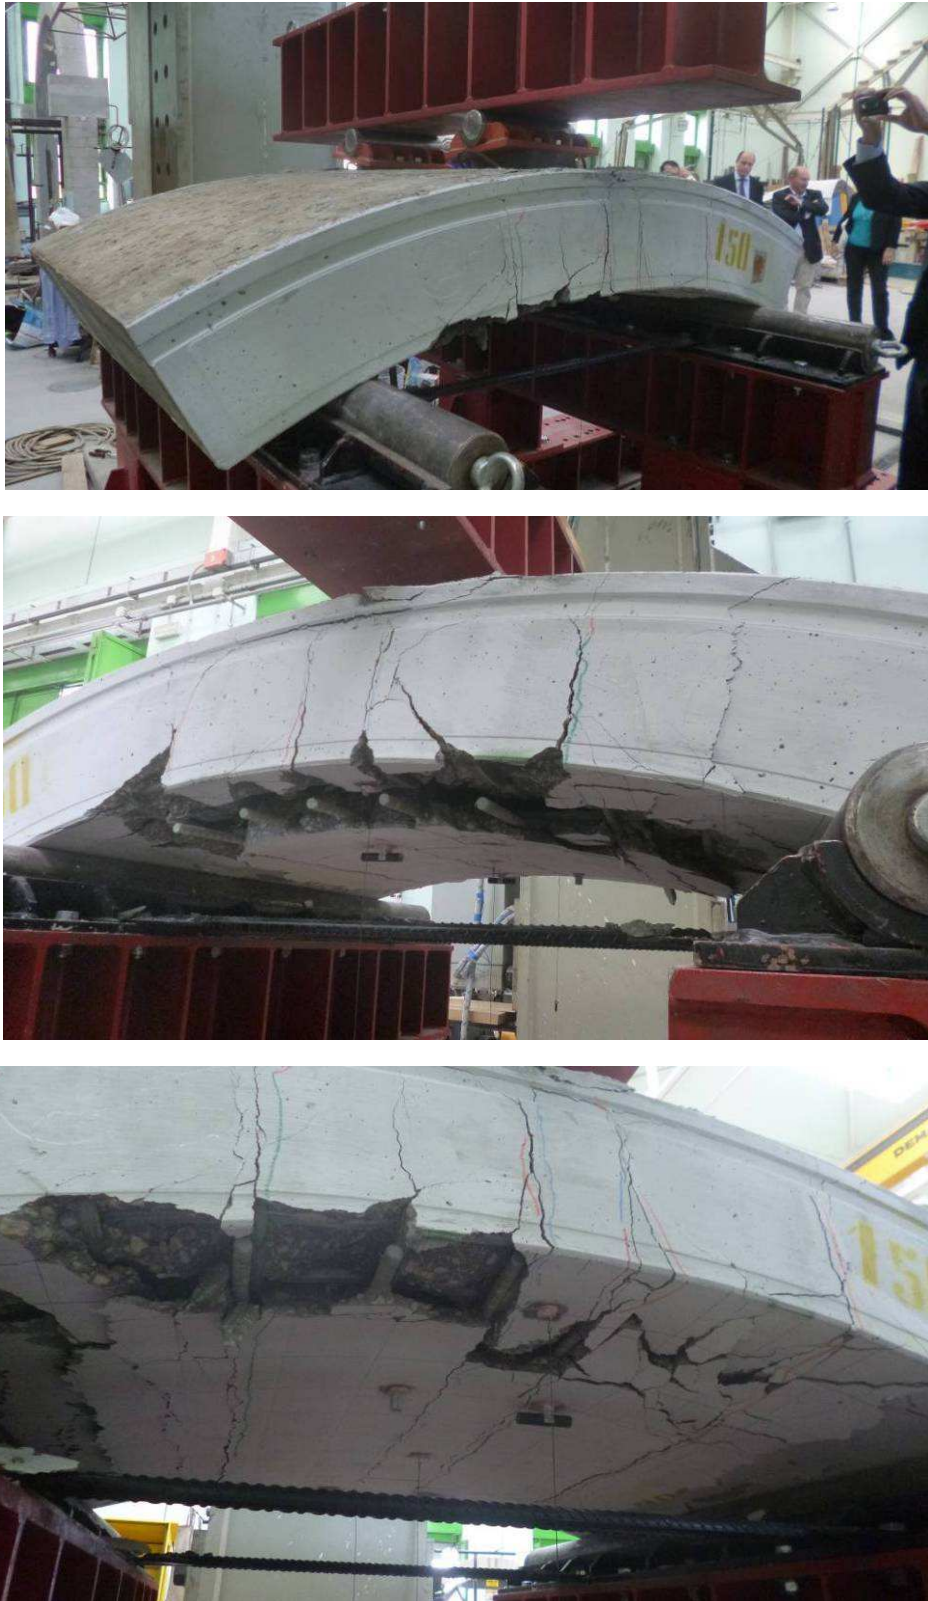
Figure 14. Failure condition

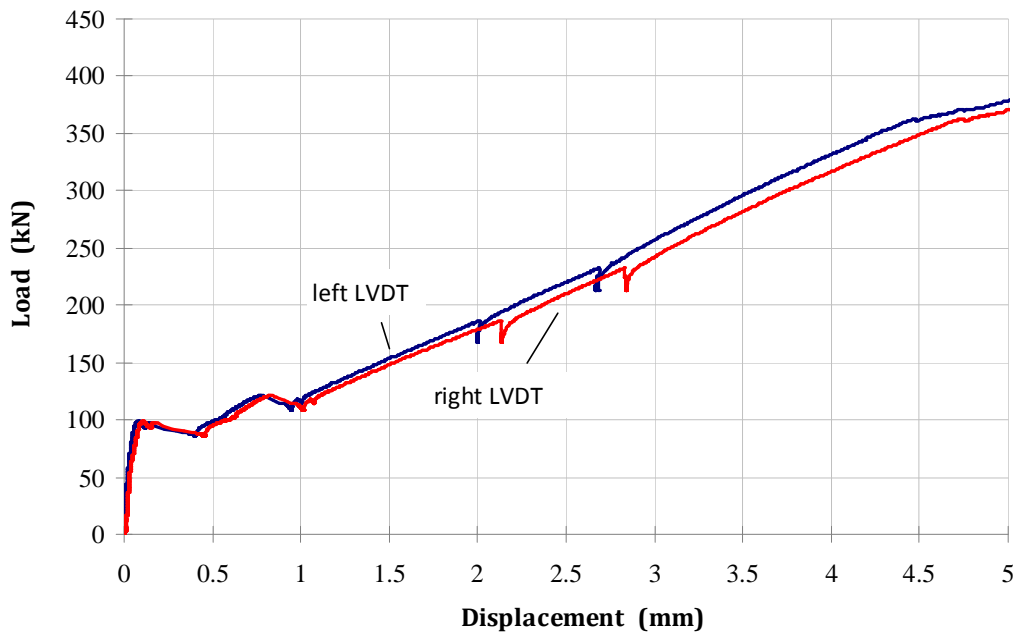
The crack width is evaluated on the basis of the two LVDTs measures. In Figure 16 the LVDTs displacements are plotted versus the load. The instruments detached from the surface for a displacement of about 5 mm.

Figure 16. Segment 150. Force-displacement diagram (LVDTs)
