**UNIVERSITA' DI ROMA "TOR VERGATA"**

## TECHNICAL REPORT

### TESTS ON PRECAST TUNNEL SEGMENTS WITH TRADITIONAL AND FIBERGLASS REINFORCEMENT

CUSTOMER: ATP S.p.A.

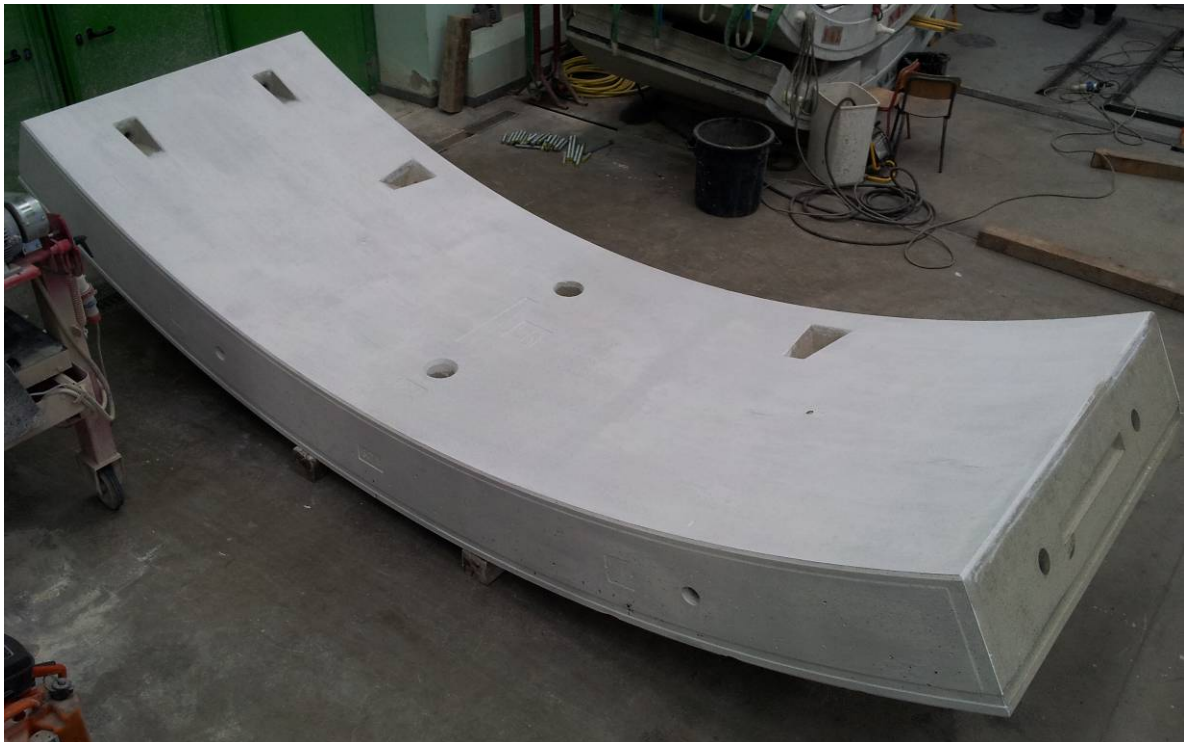
The elements are characterised by a thickness of 400 mm, a length of about 4150 mm and a width of about 1483 mm (Fig. 1).

Figure 1. Segment geometry

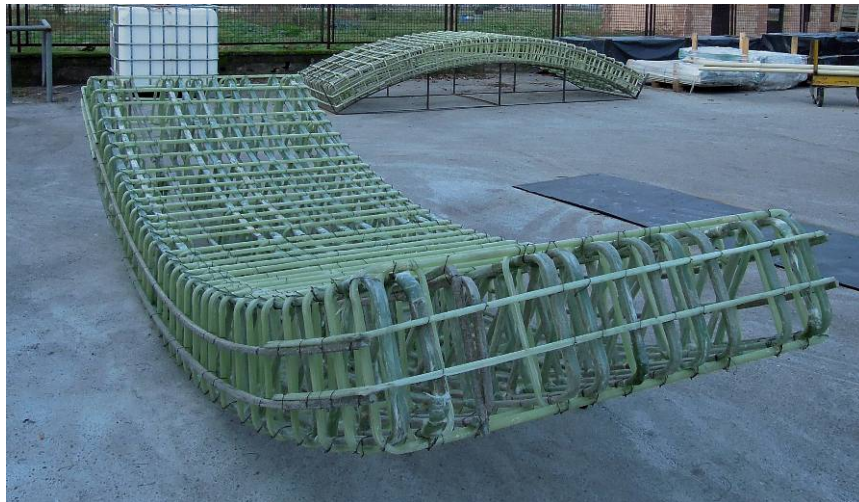
The reinforcement of the segment D5 is obtained by assembling fiberglass bars (12 $\varnothing$ 12 +12 $\varnothing$ 14 longitudinal bars, Fig. 3).

Figure 3. Segment D5: cage made fiberglass bars

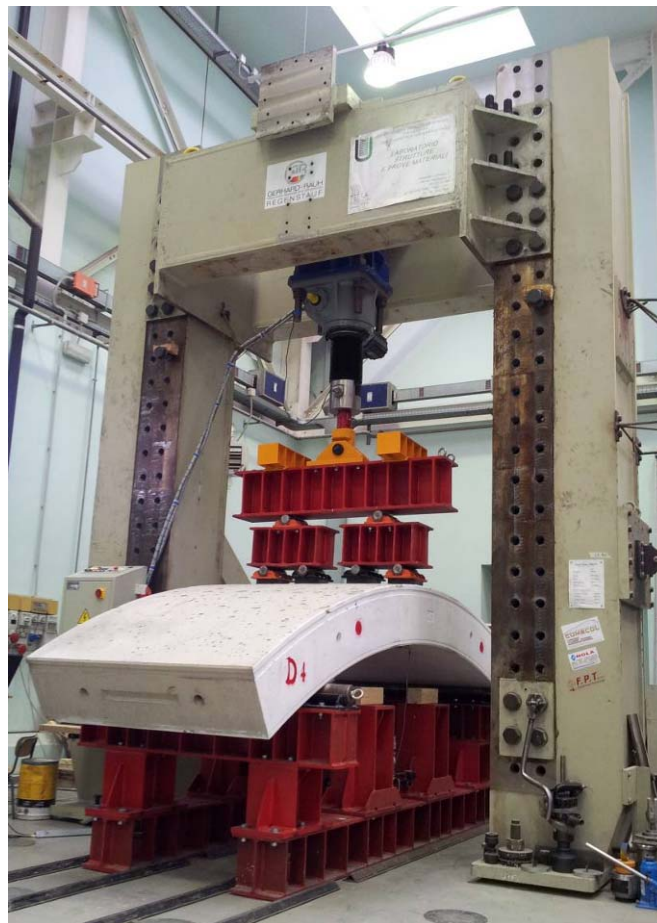
The tests were performed with the loading set-up illustrated in Figure 5a and Figure 5b, in displacement control, under a contrast frame of 4000 kN (Fig. 6) by adopting a 1000kN electromechanical jacket, with a PID control and by imposing a stroke speed of 10 – 16  $\mu\text{m}/\text{sec}$ .

Figure 5b. Bending test set-up

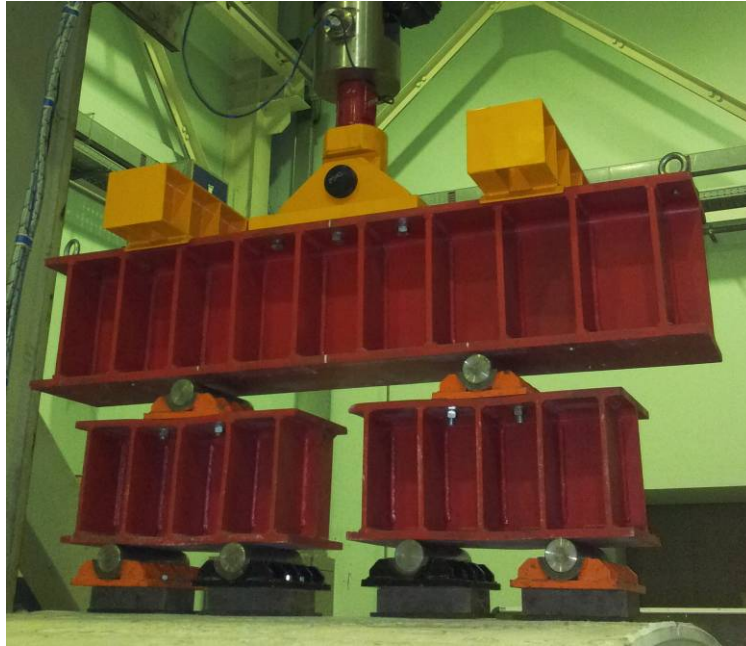
The segments were placed on cylindrical support with a span of 3000 mm and the load, applied at midspan, was transversally distributed by adopting a steel beam as shown in Figures 6 and 7.

Figure 7. Loading distribution system

1. Segment placement on the boundary system;
2. Assembling of the loading distribution system (Fig. 7);
3. First loading-unloading cycle up to 20 kN;
4. First loading-unloading cycle up to 100 kN;
5. Loading cycle up to the segment cracking;
6. Displacement increase up to the segment failure. Intermediate loading steps will be performed for the survey of the cracking pattern, as shown in the following.

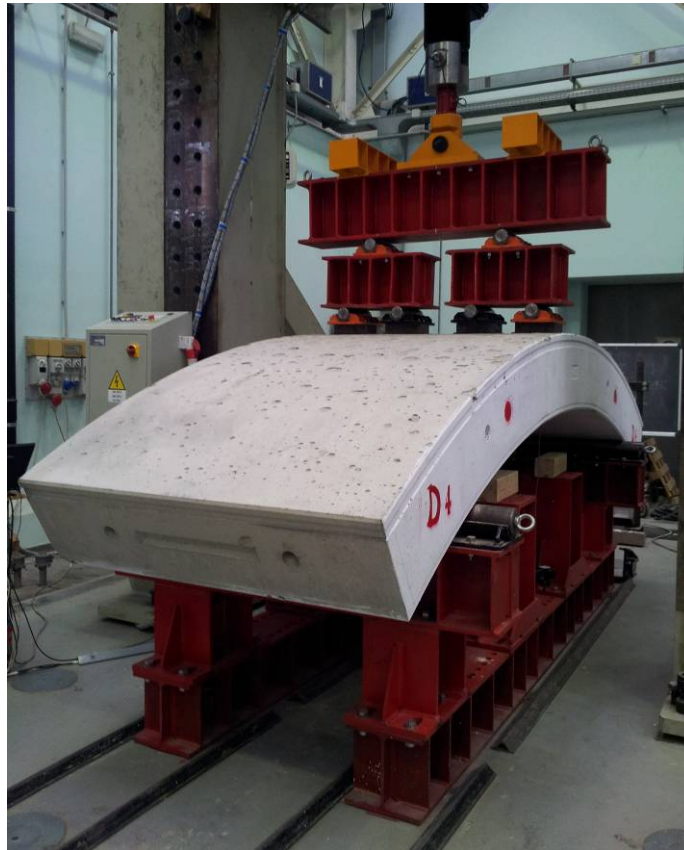
The bending test set up is highlighted in Figure 10.

Figure 10. Segment D4: Test set-up

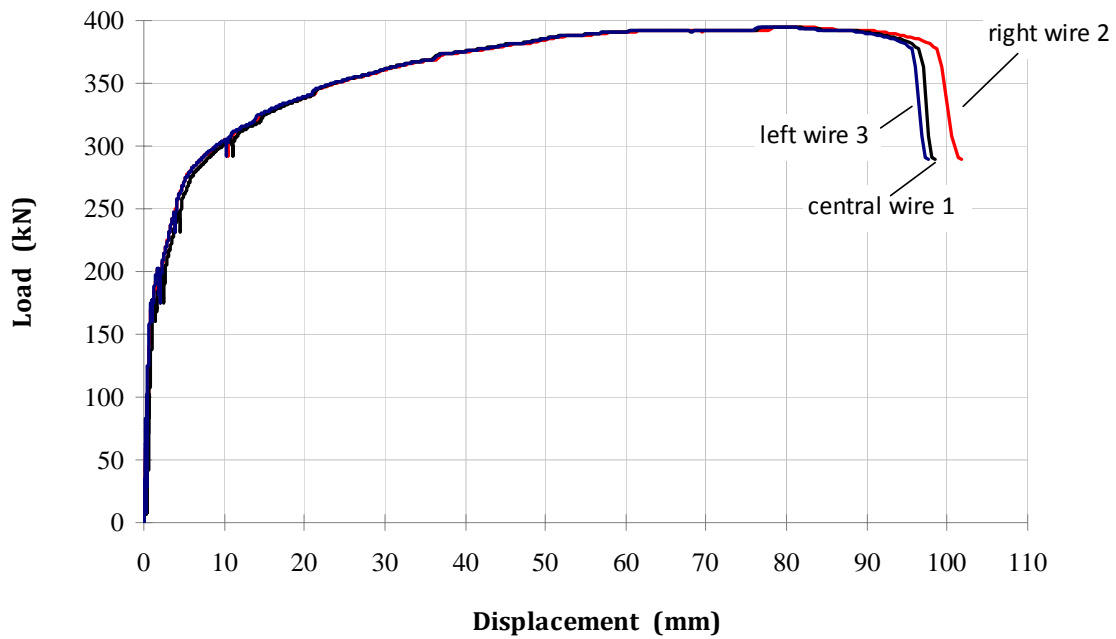
In Figure 11 it is plotted the load – displacement relationship related to the wire transducers (Fig. 8).

It is worth remarking that the three instruments, located in the midspan, measured almost coincident displacement values, highlighting a homogeneous behaviour of the segment in this direction.

The **maximum load** is equal to about 395 kN.

Figure 11. Segment D4: Load –Displacement diagram

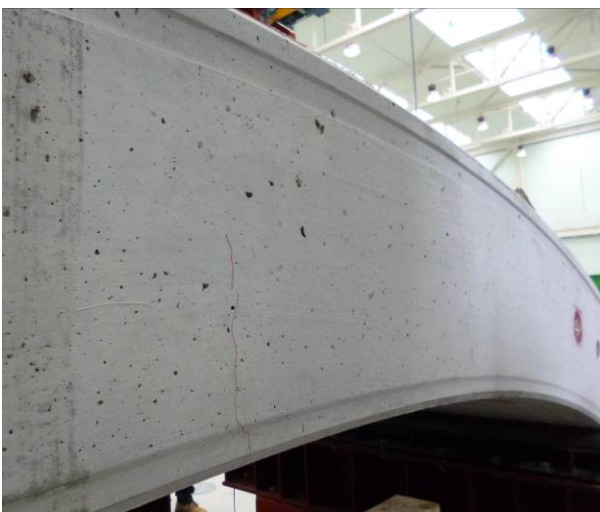
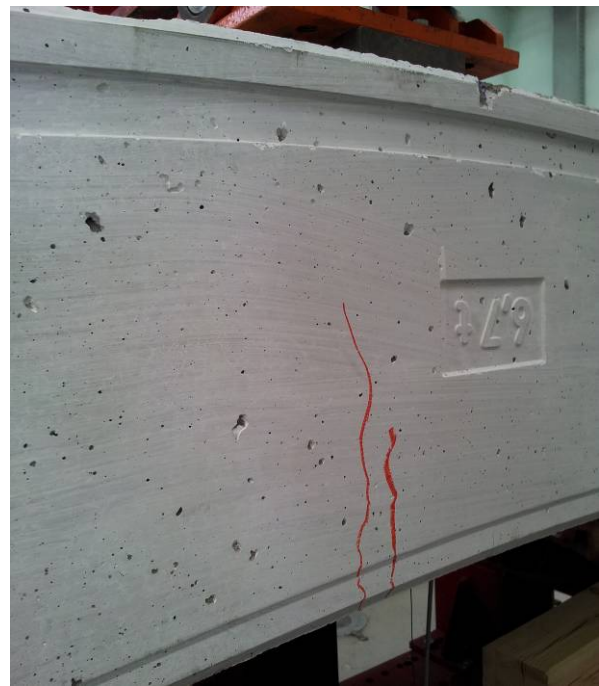
The first cracks opened for a load value of about 175 kN close to the midspan of the segment on the lateral and intrados surfaces (Figs. 12 and 13).

Figure 12. Segment D4: load level of 175 kN; a) left lateral surface, b) right lateral surface

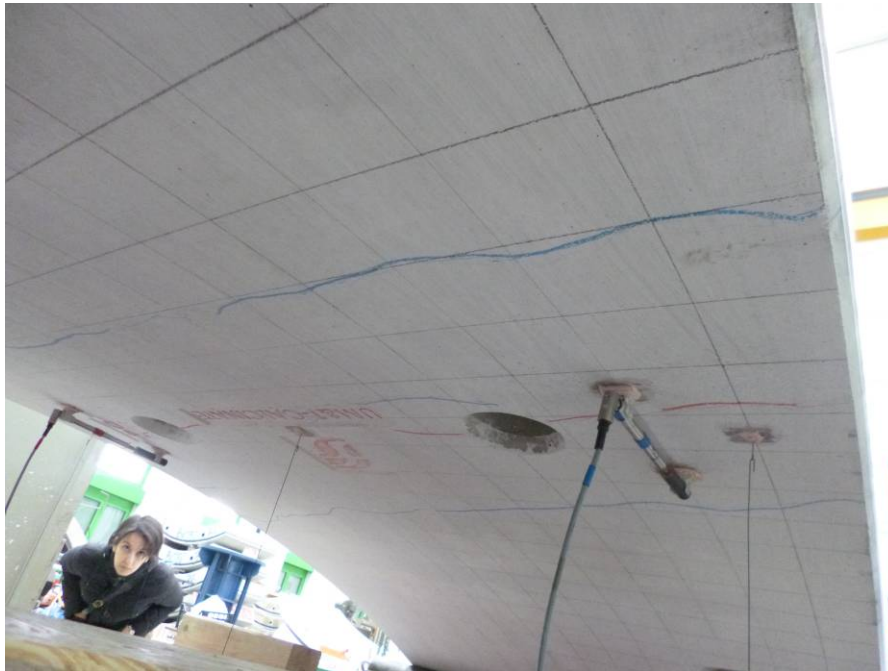
The crack pattern on the lateral and intrados surfaces, for a load level of 200 kN is highlighted in Figures 14 and 15. The maximum crack width is equal to 0.3 mm, as shown in Figure 16.

Figure 15. Segment D4: load level of 200 kN, intrados surface

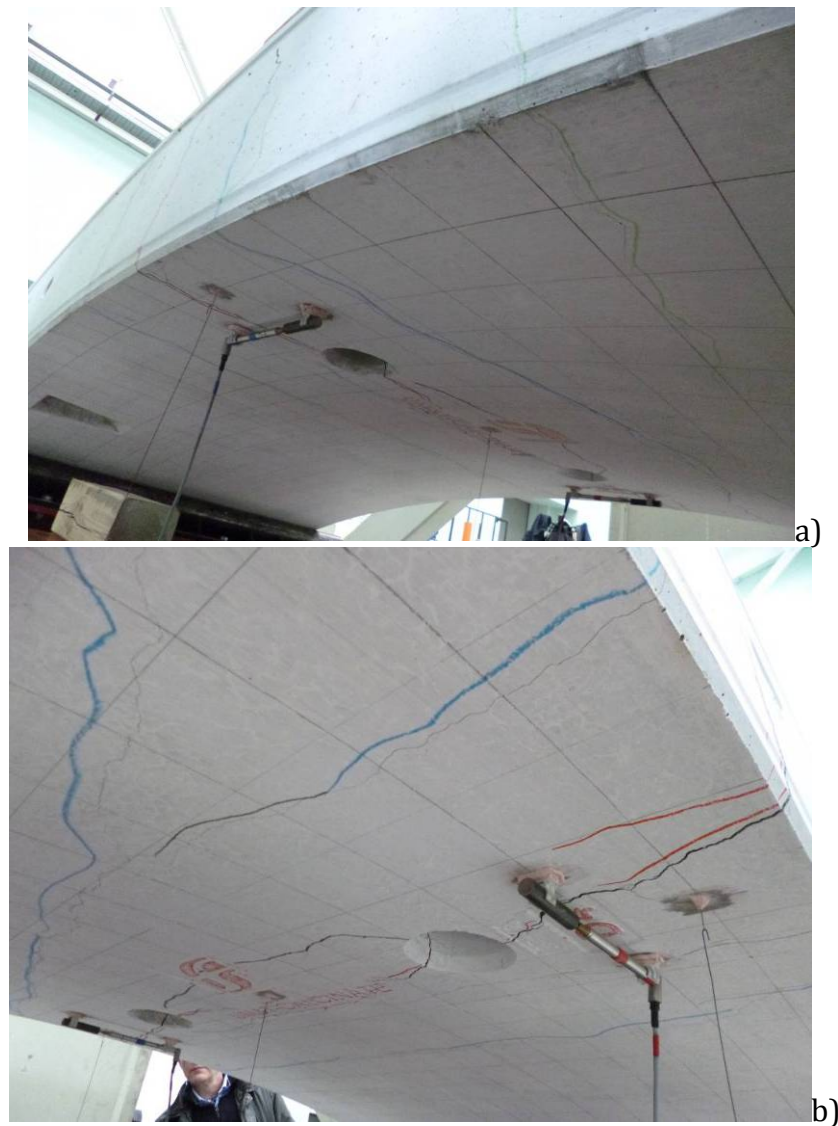
The crack distribution for a load level of 300 kN is highlighted in Figures 17 and 18. The maximum crack width is equal to about 3 mm, as shown in Figure 19.

Figure 18. Segment D4: load level of 300 kN – intrados surface; a) left side; b) right side

The measured values refer to the one main crack that gets across the instruments (Fig. 18).

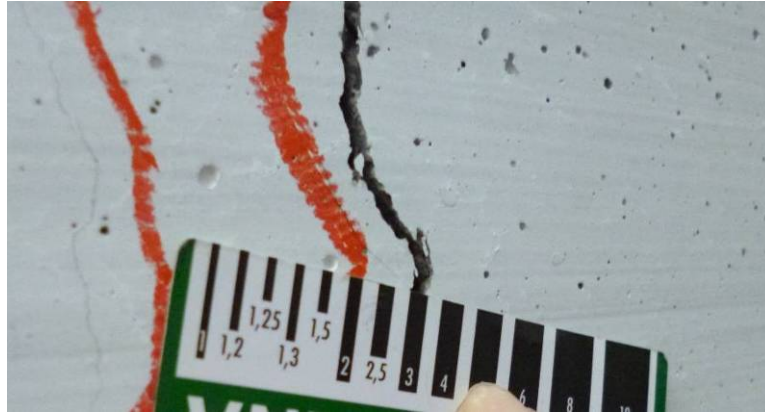
Figure 19. Segment D4: load level of 300 kN, maximum crack width.

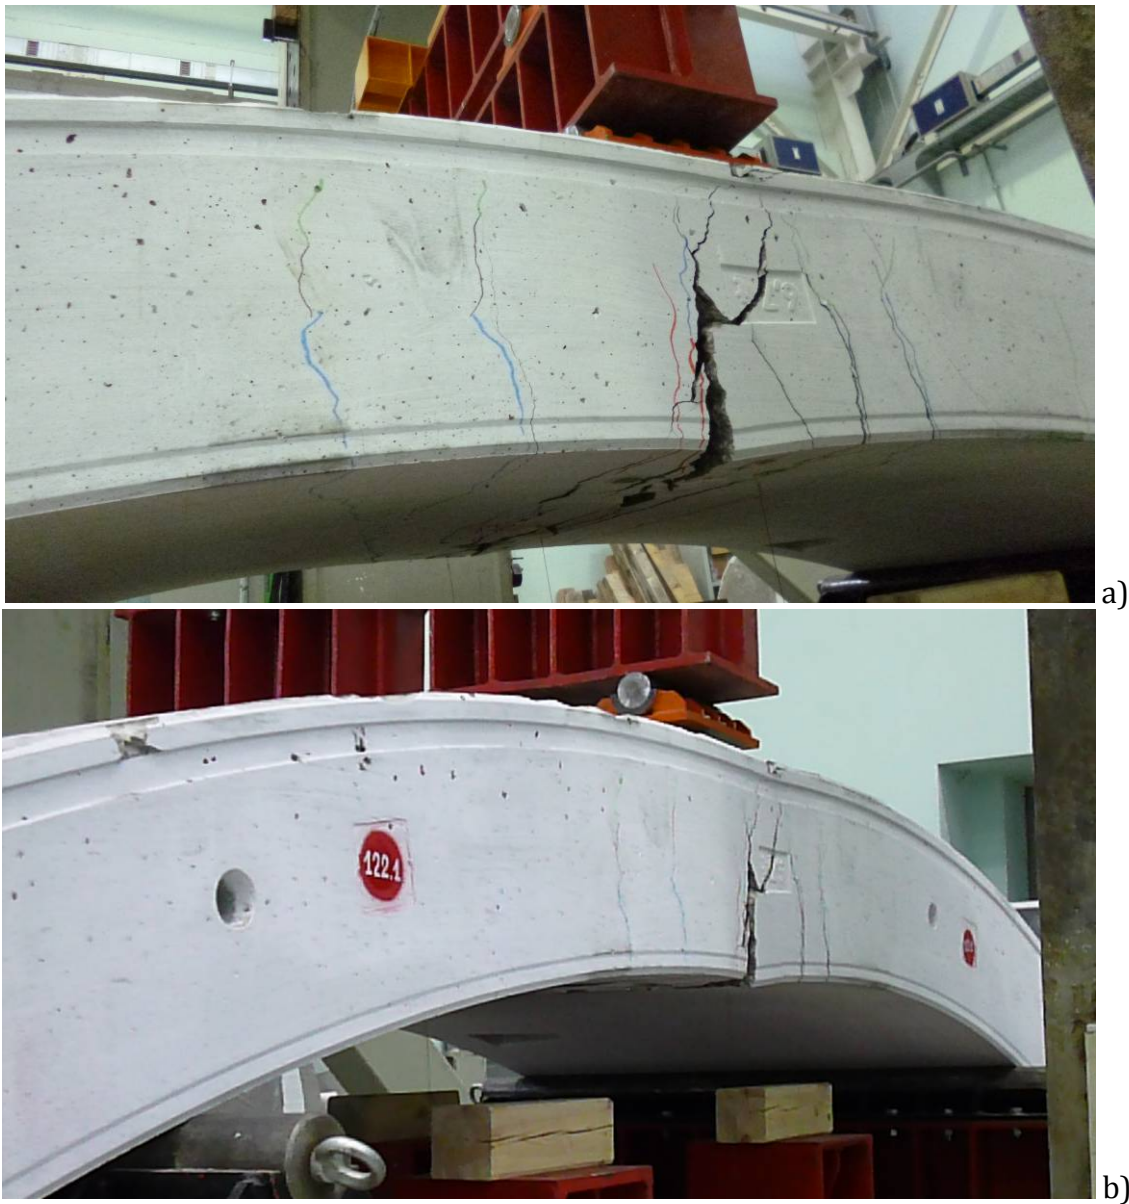
The crack pattern related the ultimate state is plotted in Figures 20 and 21. The final crack pattern, at the end of the test is summarised in Figure 22.

Figure 20. Segment D4: failure stage a) left lateral surface, b) right lateral surface.

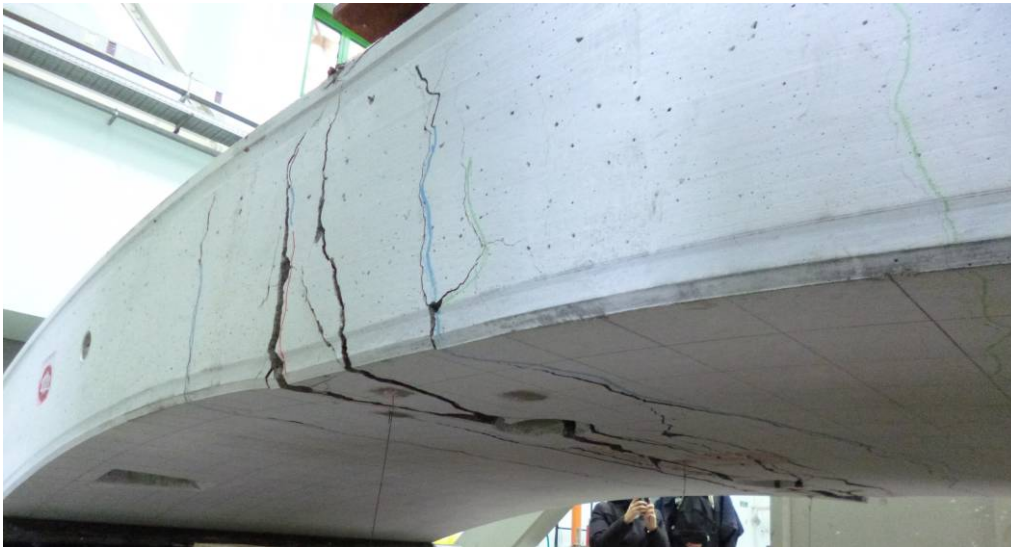
Figure 21. Segment D4: failure stage: intrados surface.

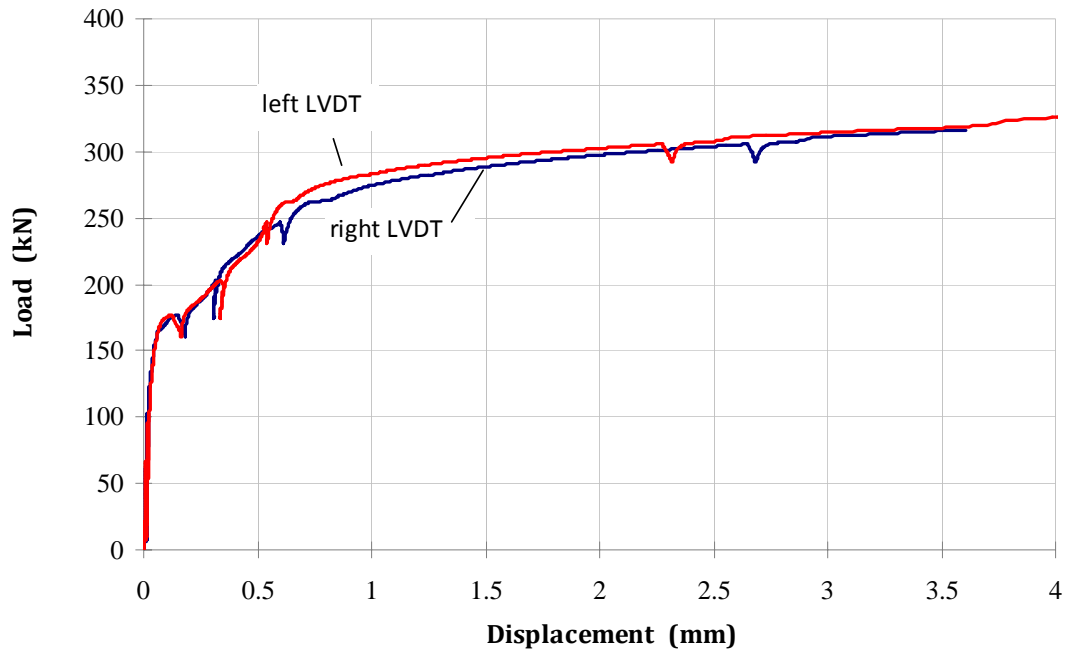
The crack width is evaluated on the basis of the two LVDTs measures. In Figure 23 the LVDTs displacements are plotted versus the load.

Figure 23. Segment D4. Force-displacement diagram (LVDTs)

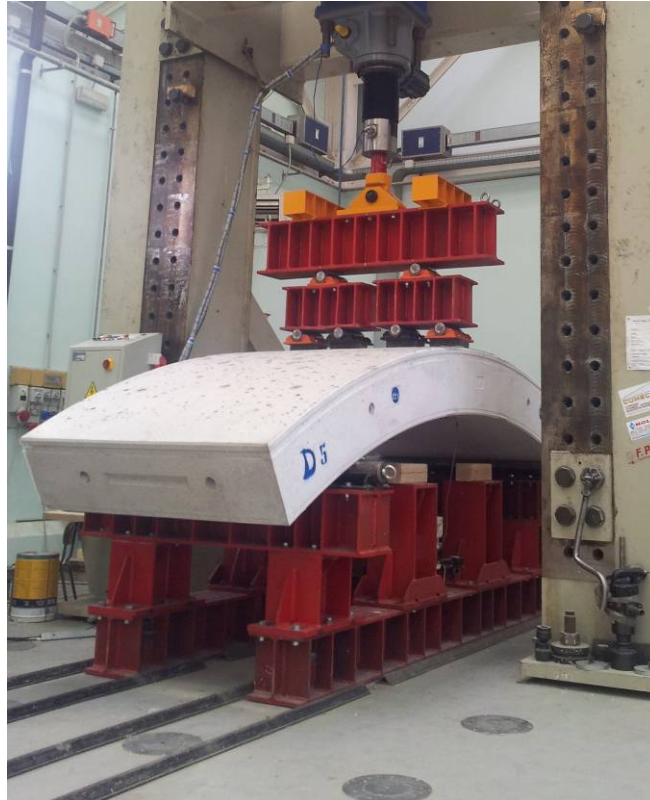
The bending test set up is highlighted in Figure 24.

Figure 24. Segment D5: Test set-up

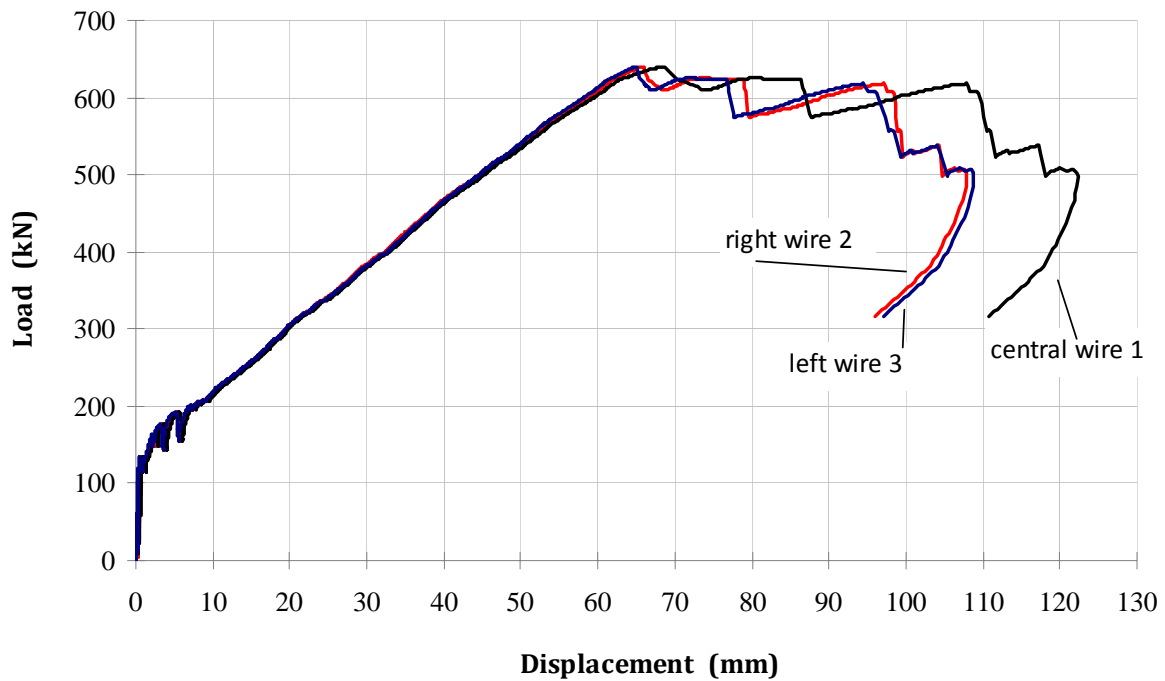
In Figure 25 it is plotted the load – displacement relationship related to the wire transducers (Fig. 8).

It is worth remarking that the three instruments, located in the midspan, measured very similar displacement values, highlighting a homogeneous behaviour of the segment in this direction.

The **maximum load** is equal to about 640 kN.

Figure 25. Segment D5: Load -Displacement diagram

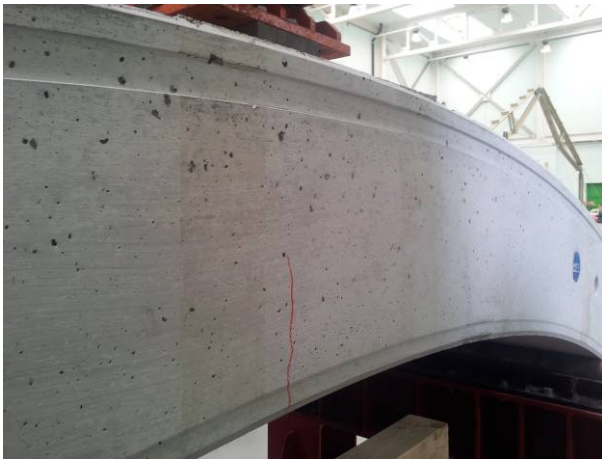
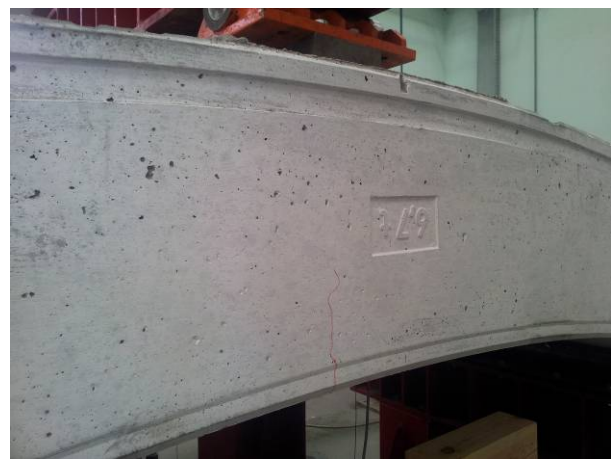
The first cracks opened for a load value of about 130 kN close to the midspan of the segment on the lateral and intrados surfaces (Figs. 26 and 27).

Figure 26. Segment D5: load level of 130 kN; a) left lateral surface, b) right lateral surface

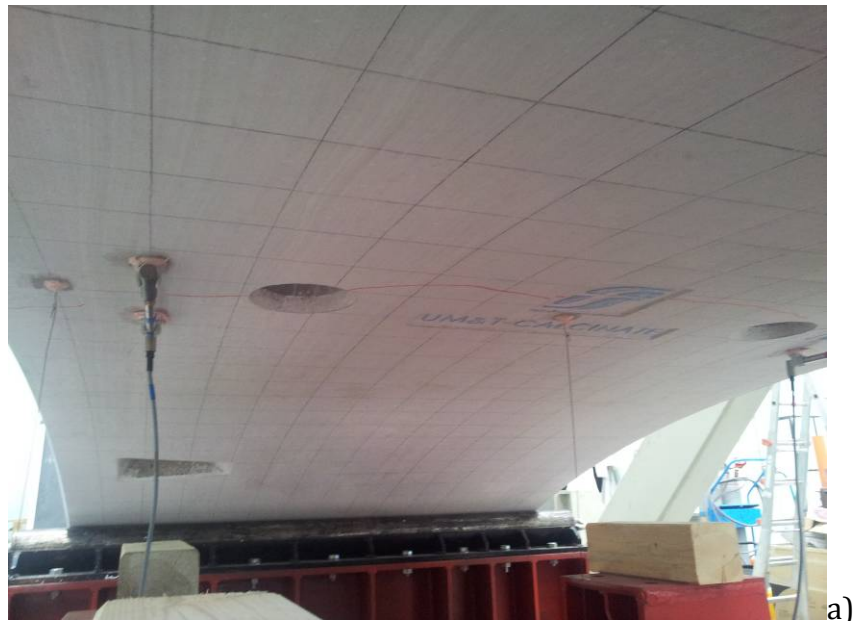
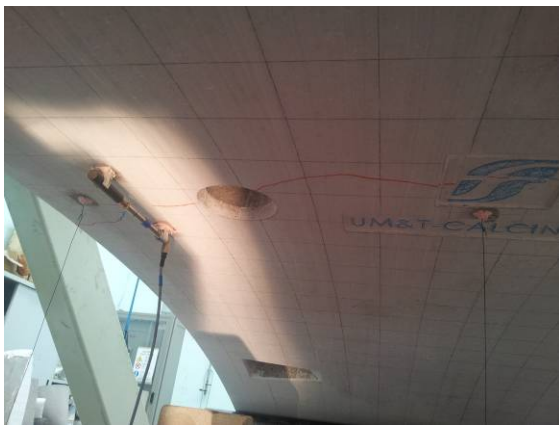
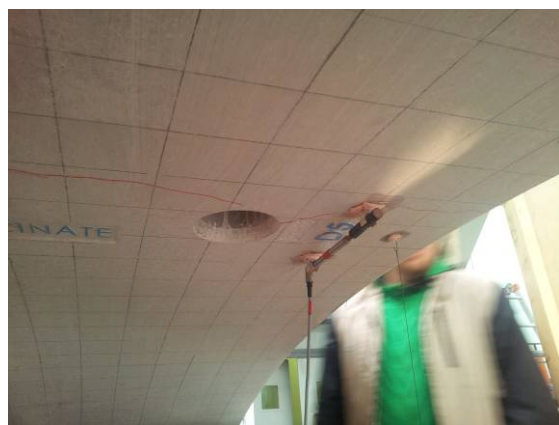
Figure 27. Segment D5: load level of 130 kN intrados surface(a); b) left side; c) right side

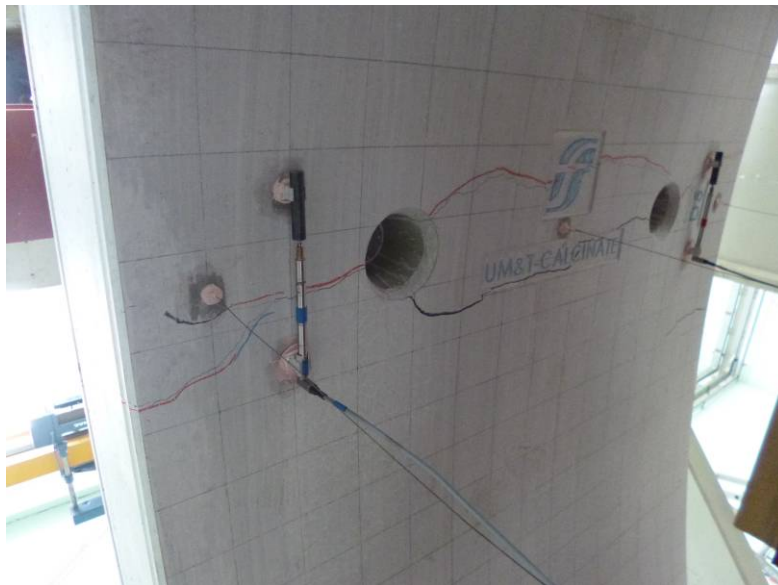
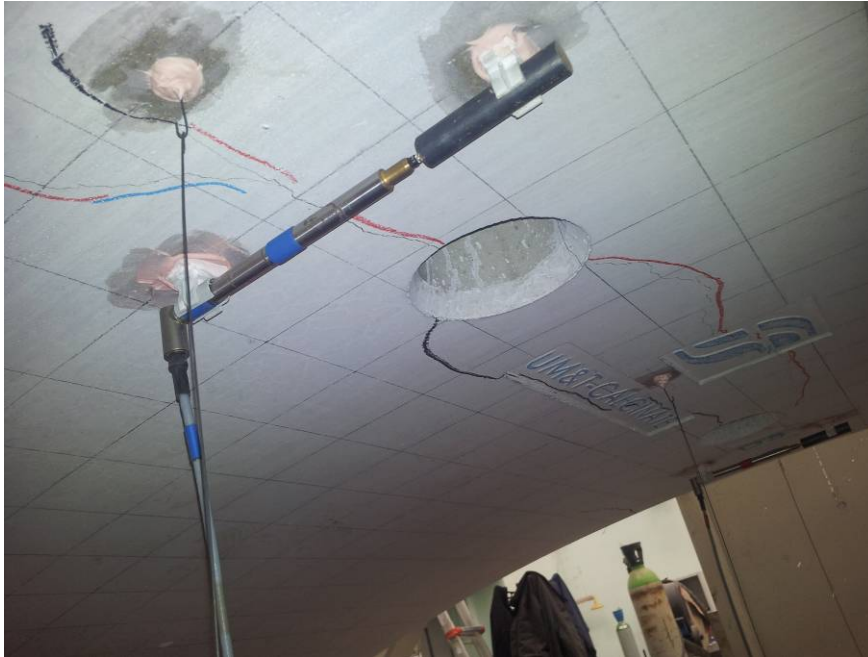
The crack pattern on the lateral and intrados surfaces, for a load level of 160 kN is highlighted in Figures 28 and 29. The maximum crack width is equal to 0.7 mm, as shown in Figure 30.

Figure 29. Segment D5: load level of 160 kN, intrados surface

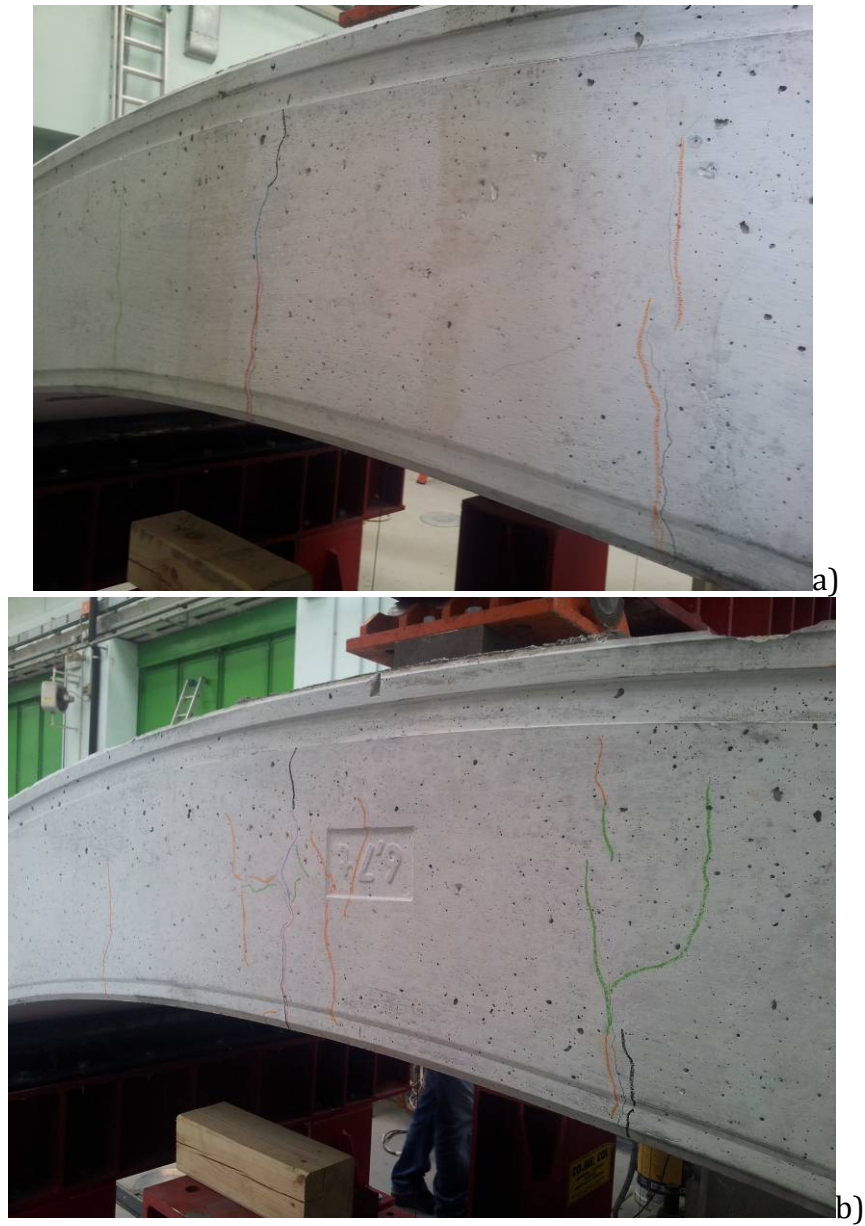
Figure 31. Segment D5: load level of 195 kN; a) left lateral surface, b) right lateral surface.

The crack distribution for a load level of 195 kN is highlighted in Figures 31 and 32. The maximum crack width is equal to about 1.3 mm, as shown in Figure 33.

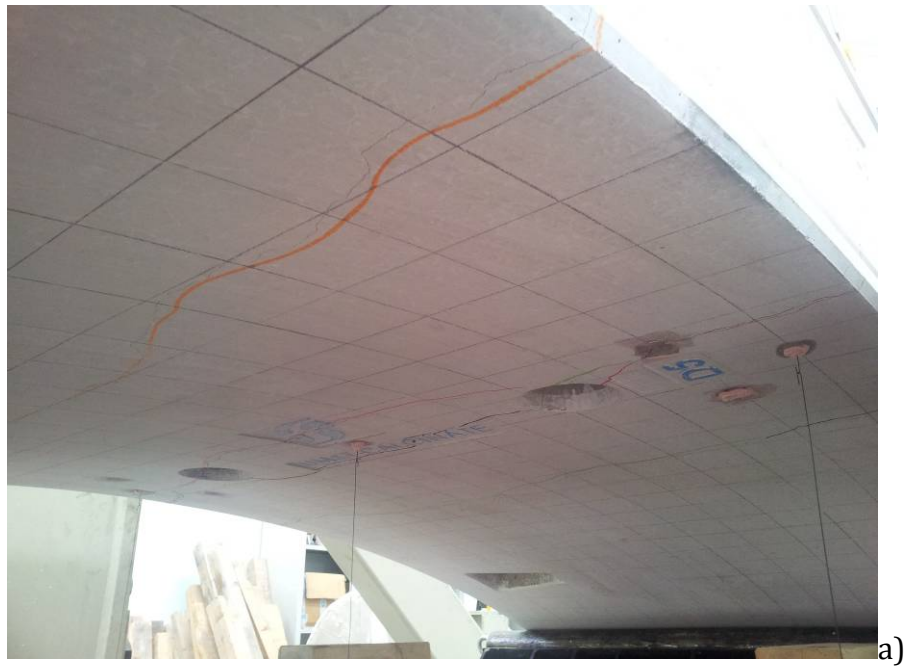
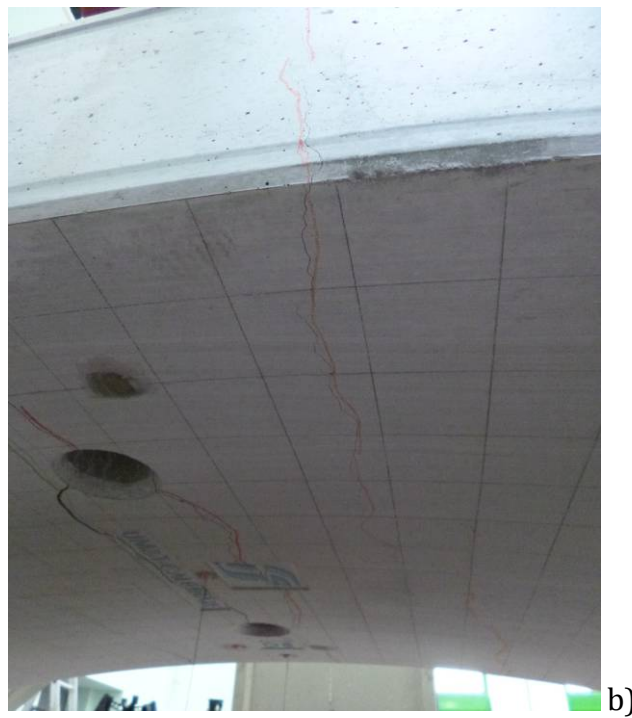
Figure 32. Segment D5: load level of 195 kN – intrados surface

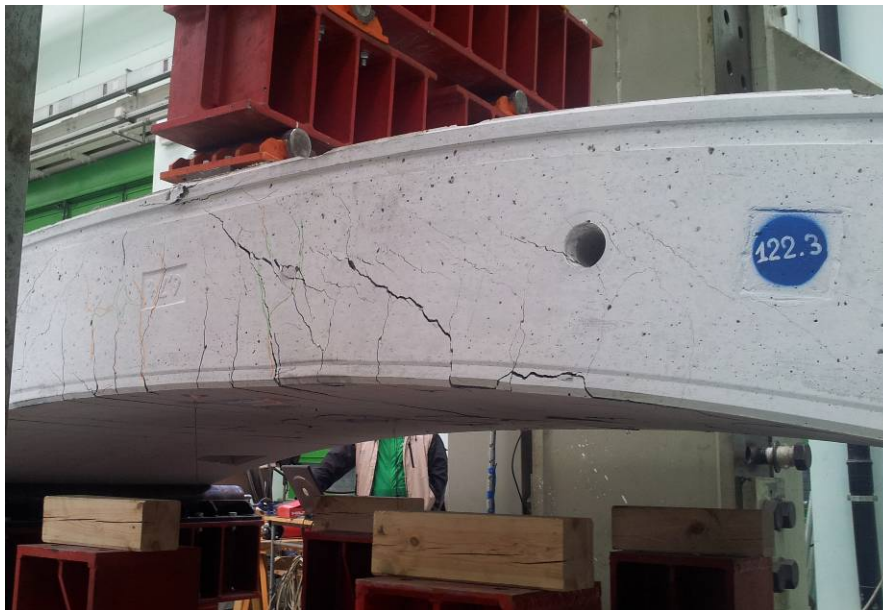
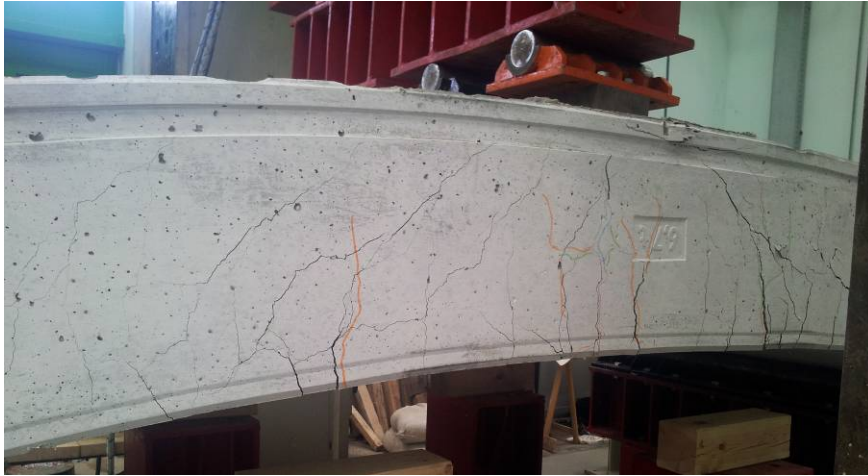
Figure 34. Segment D5: failure stage: right lateral surface.

The crack pattern related the ultimate state is plotted in Figures 34, 35 and 36. The final crack pattern, at the end of the test is summarised in Figure 37.

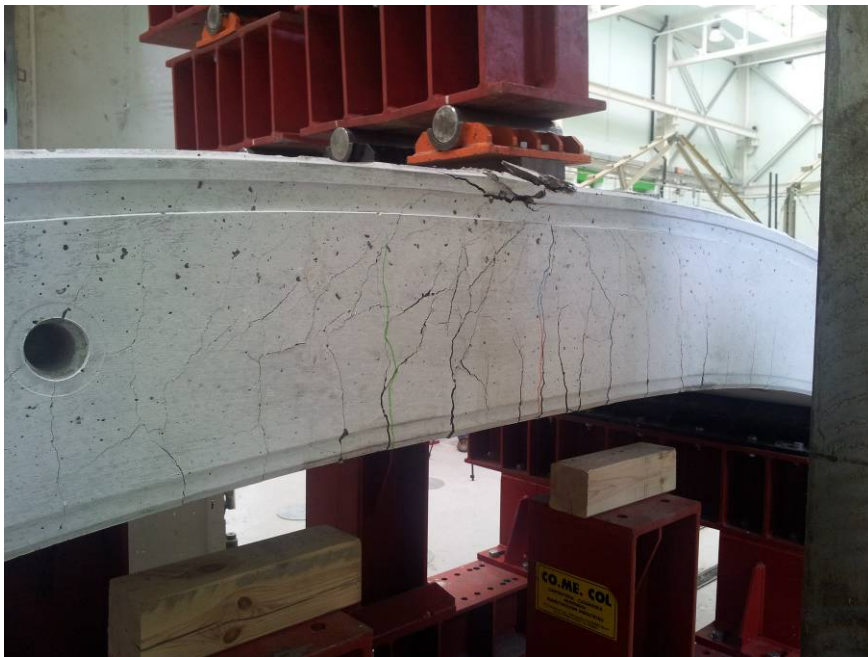
Figure 35. Segment D5: failure stage: left lateral surface.

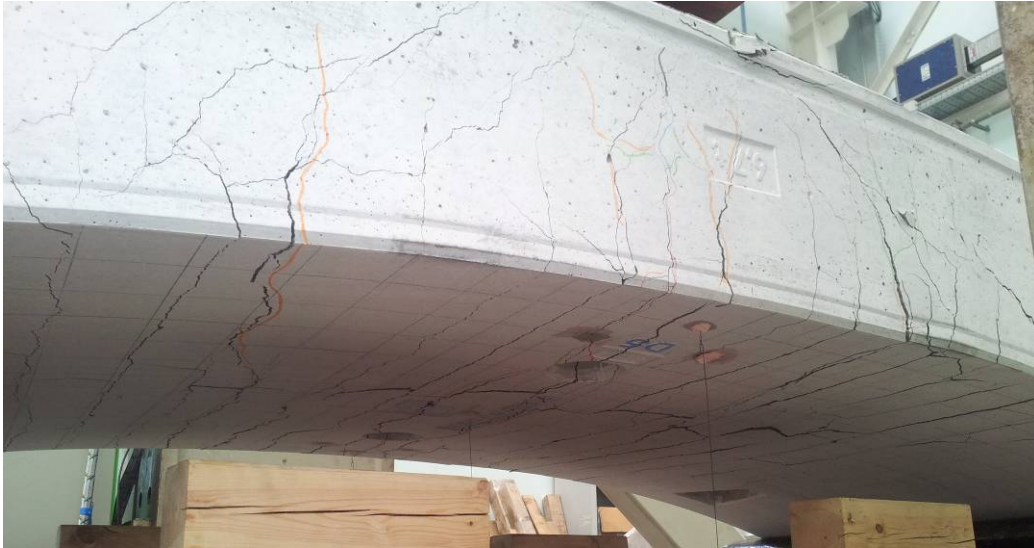
Figure 36. Segment D5: failure stage: intrados surface.

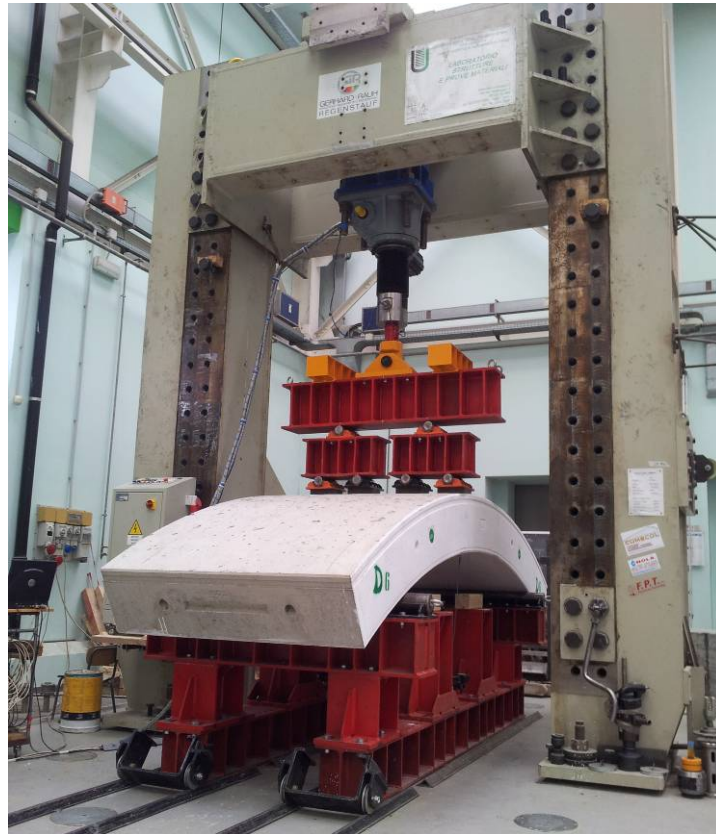
Figure 38. Segment D6: Test set-up

The bending test set up is highlighted in Figure 38.

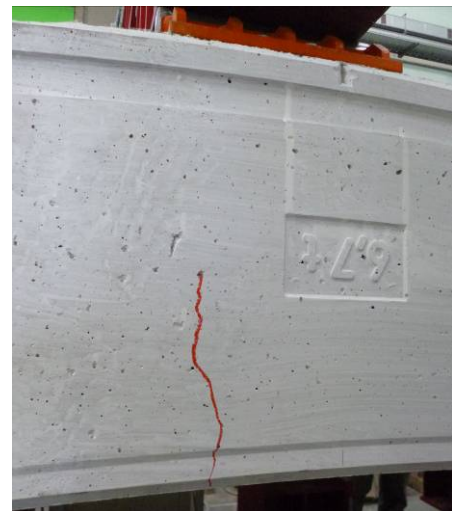
Figure 40. Segment D6: load level of 140 kN; a) left lateral surface, b) right lateral surface

The first cracks opened for a load value of about 140 kN close to the midspan of the segment on the lateral and intrados surfaces (Figs. 40 and 41).

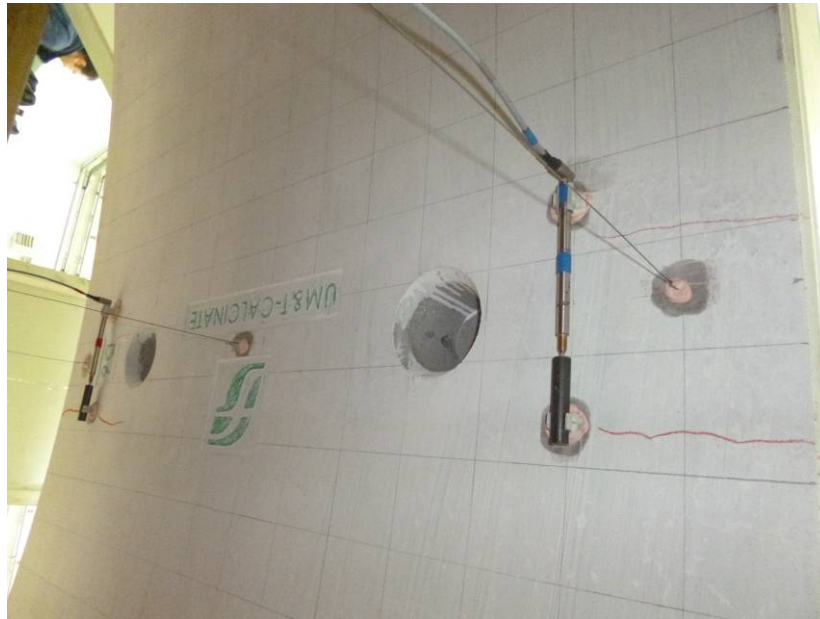
Figure 41. Segment D6: load level of 140 kN intrados surface

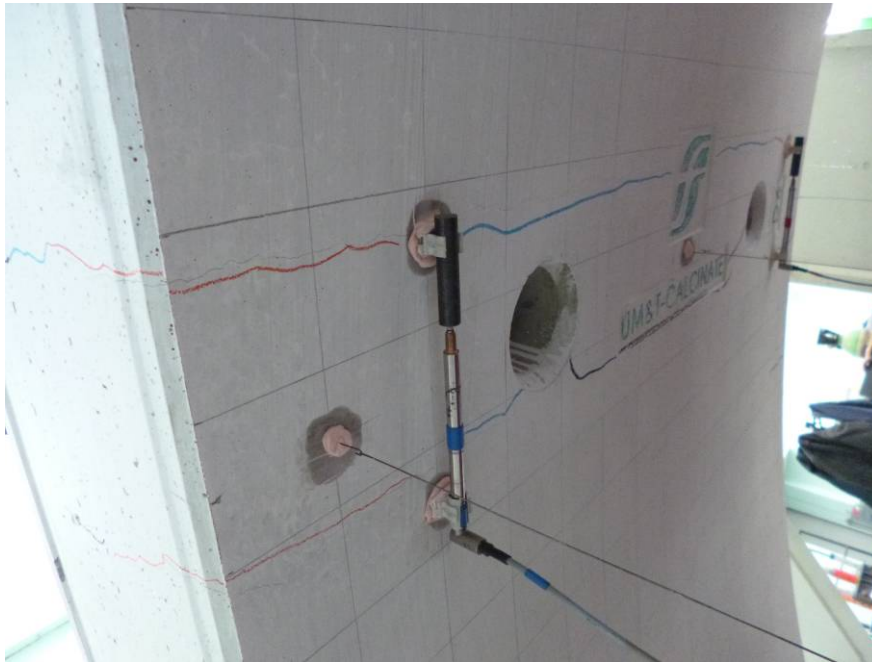
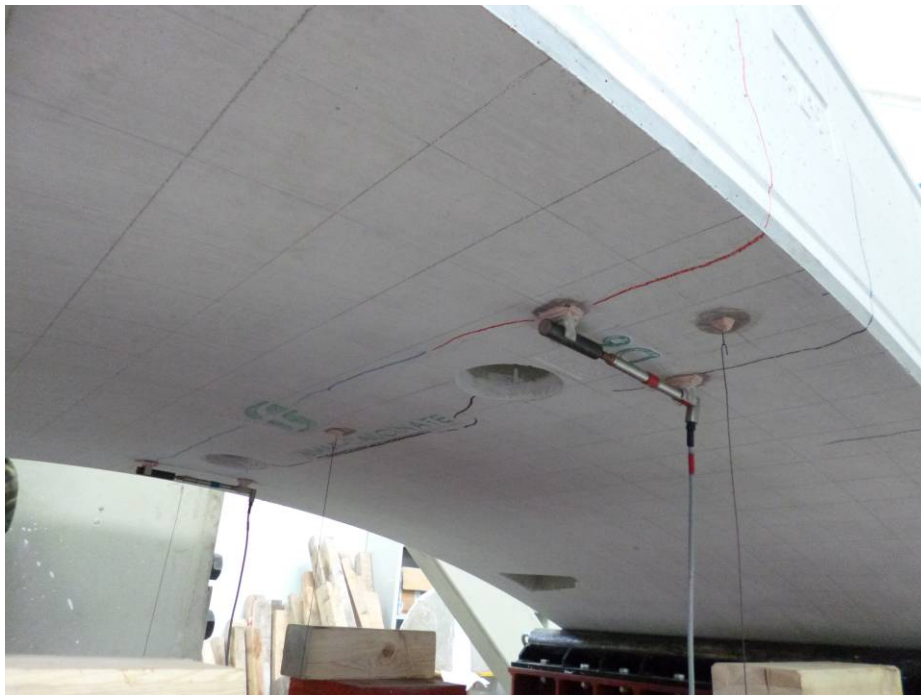
Figure 43. Segment D6: load level of 164 kN, intrados surface

The crack pattern on the lateral and intrados surfaces, for a load level of 164 kN is highlighted in Figures 42 and 43. The maximum crack width is equal to 0.7 mm, as shown in Figure 44.

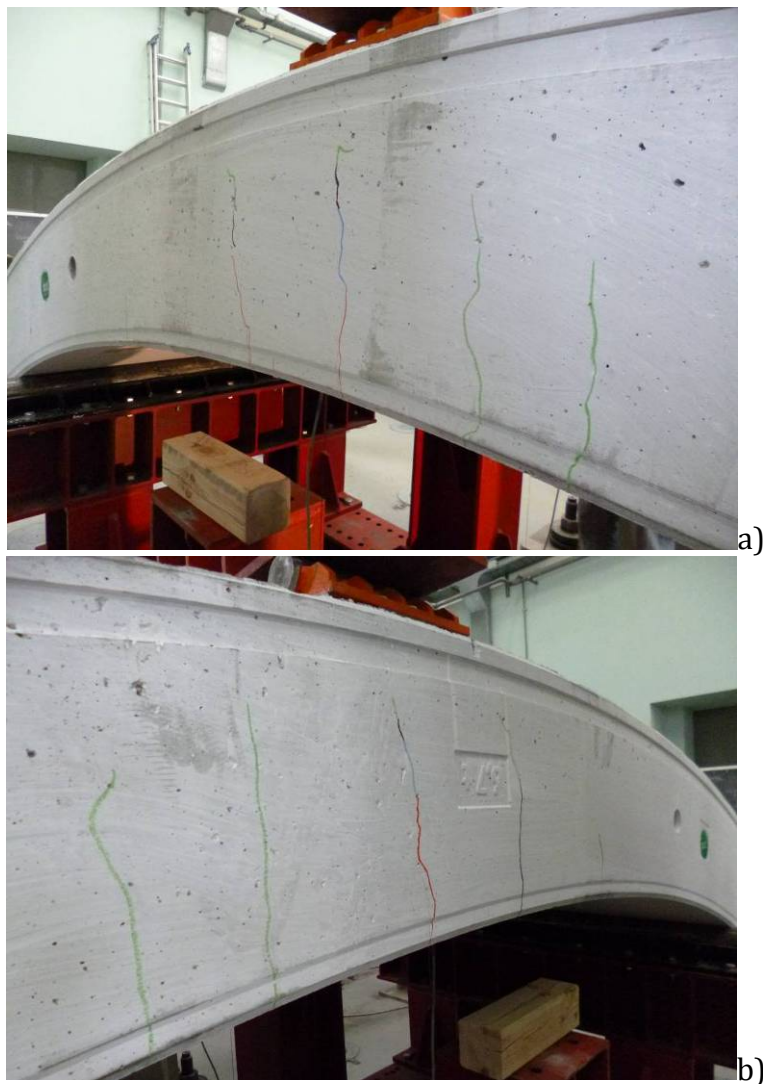
Figure 45. Segment D6: load level of 185 kN; a) left lateral surface, b) right lateral surface.

The crack distribution for a load level of 185 kN is highlighted in Figures 45 and 46. The maximum crack width is equal to about 3 mm, as shown in Figure 47.

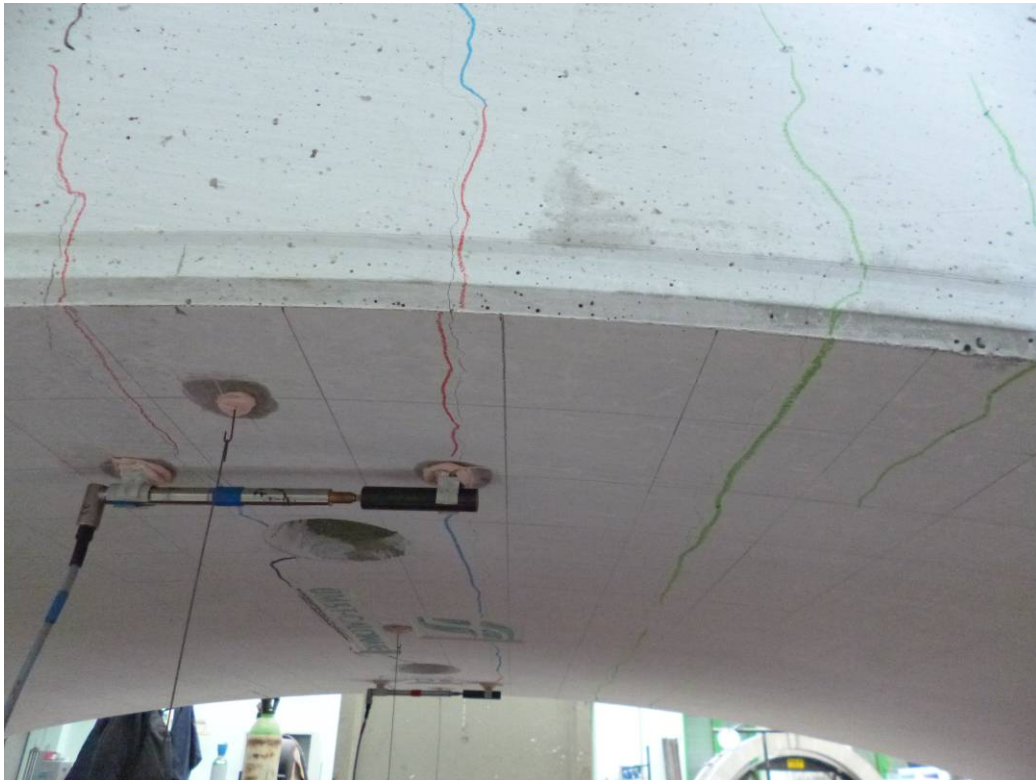
Figure 46. Segment D6: load level of 185 kN – intrados surface

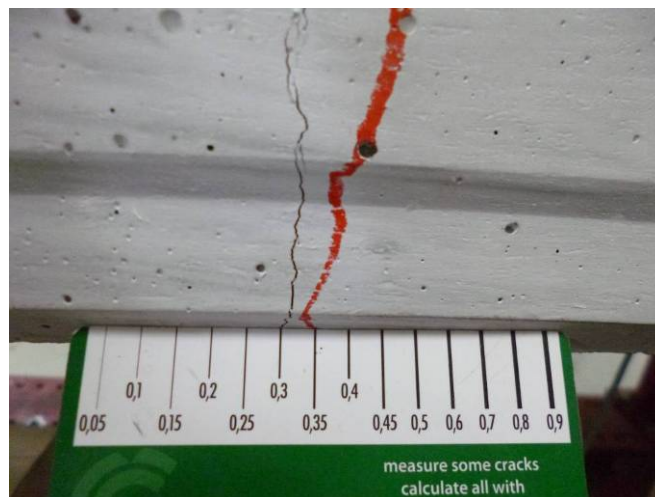
Figure 47. Segment D6: load level of 185 kN, maximum crack width.
