**UNIVERSITA' DI ROMA "TOR VERGATA"**

## TECHNICAL REPORT

### TESTS ON PRECAST TUNNEL SEGMENTS WITH TRADITIONAL AND FIBERGLASS REINFORCEMENT

CUSTOMER: ATP S.p.A.

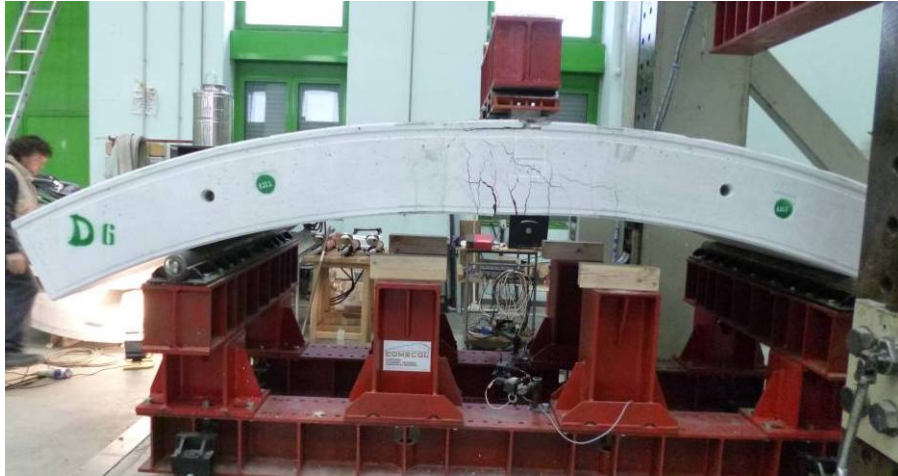
Figure 48. Segment D6: failure stage: right lateral surface.

The crack pattern related the ultimate state is plotted in Figures 48, 49 and 50. The final crack pattern, at the end of the test is summarised in Figure 51.

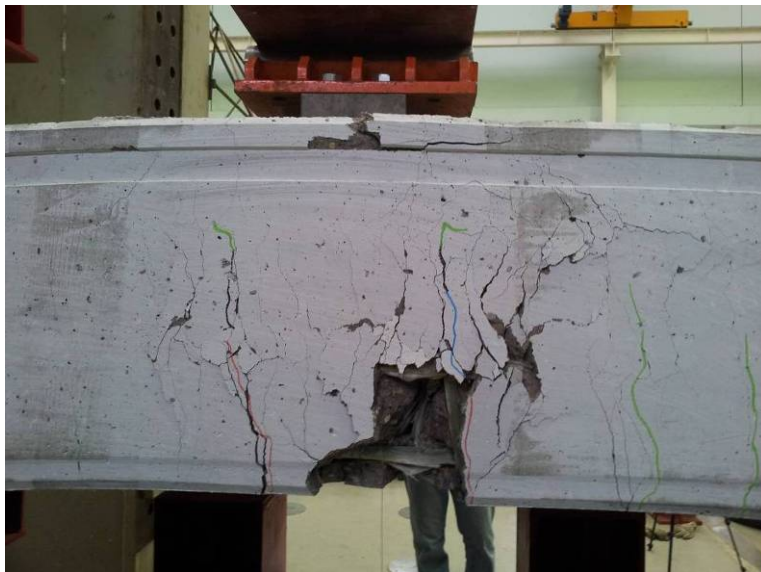
Figure 49. Segment D6: failure stage: left lateral surface.

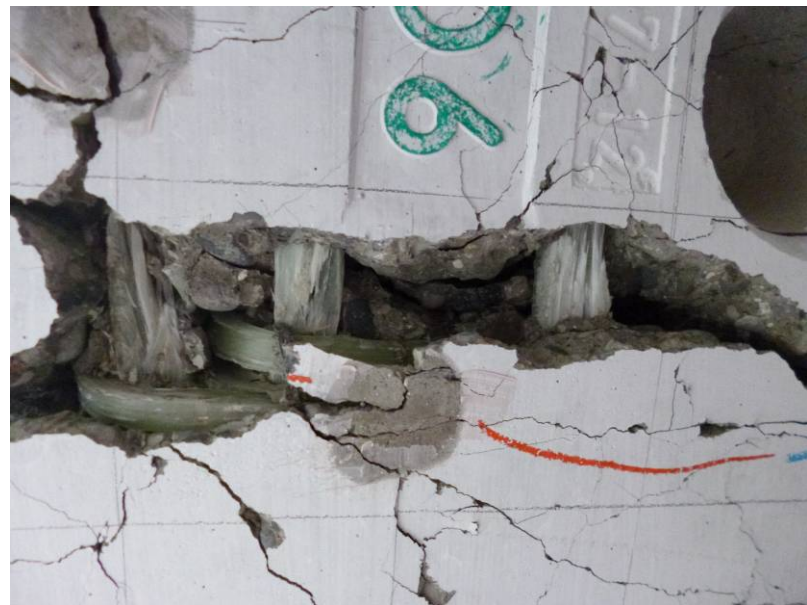
Figure 50. Segment D6: failure stage: intrados surface.
